A Survey of Failure in Automobile Engine Crankshaft

Ashok D Wale

Mechanical Engineering Department
Amrutvahini Polytechnic, Sangamner, Maharashtra, India

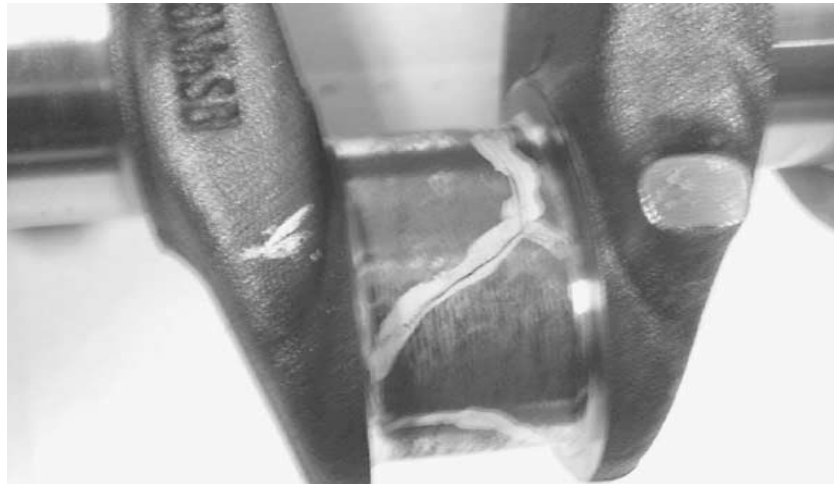
Operating sources such as oil absence or defective lubrication of journals would be enough to damage the journals. The contact between the bearings and the journals would develop a rougher surface of the journals. The heat and stresses during the contact would also eventually promote the propagation of existing cracks as shown in fig. 4.1.

Fig. 4.1 Propagation of existing cracks

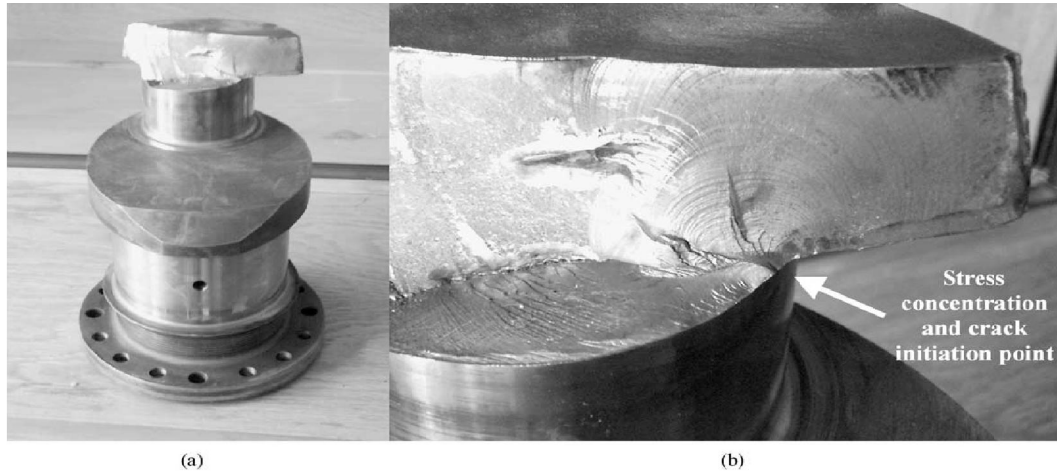
Fig.4.2 a) Part of crankshaft,
b) Detail of mechanical fatigue crack which developed at a stress concentration.

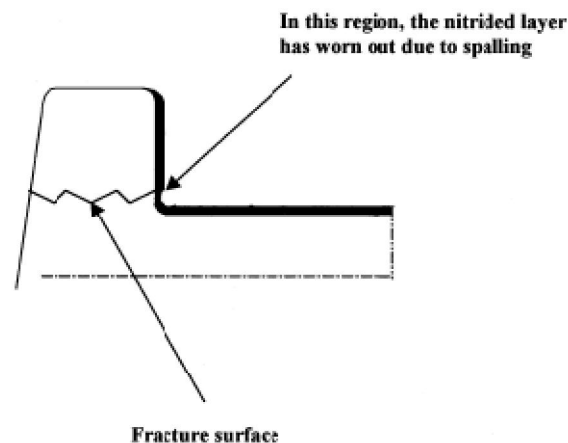
Surface Contact Fatigue occurred due misalignment or axial movement of the shaft. Due to some axial load on the shaft, the bearing has moved causing it to rub constantly against the journal web. The fatigue crack had originated at the web radius region. The fatigue crack initiation seems to be due to the degradation of the shaft during service. Mechanical degradation such as pitting and spalling were occurred. This has led to a situation of surface contact fatigue resulting in extensive pitting and spalling of the nitrided layer at the web radius region of the journals. Under the cyclic loading, fatigue cracks have initiated at these stress concentration points leading to fracturing of the shaft. Fig. 5.1 shows the schematically damage of the nitrided layer.[4]

Fig. 5.1 Damage of nitrided surface in web radius due to pitting and spalling.

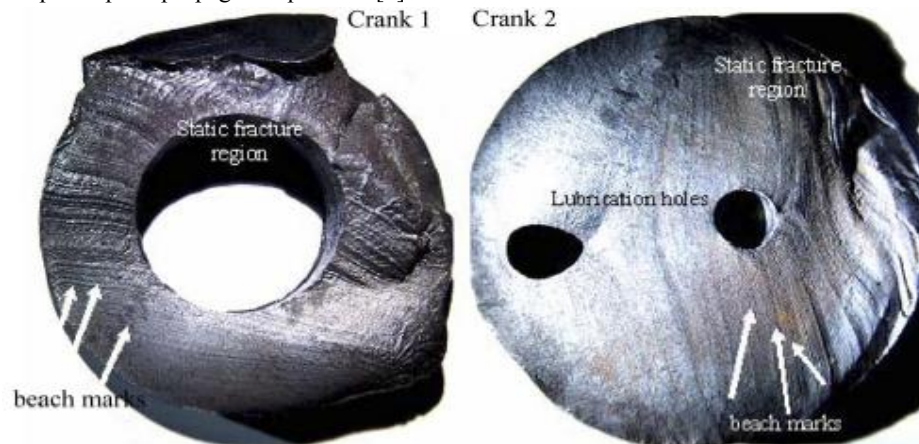
The fatigue crack initiated at the sharp fillet region as shown in fig.6.2 The sharp fillet creates relatively high stress concentration for the crankshaft subjected to bending and torsional loading during a stroke process. The failure has began at the sharp fillet region and the diagonal lubrication holes in the Crankshaft cause to turn the crack propagation direction and speed up the propagation process. [2]

Fig .5.2.Failed crankshaft and their fracture surfaces at sharp fillet region.

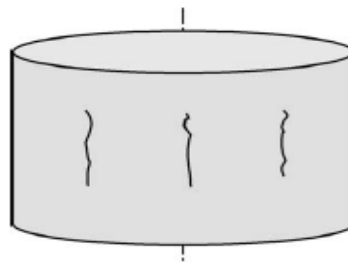
A thermal gradient in a body creates thermal stresses due to expansion in warmer areas. If this temperature gradient is repeated for several times, e.g. an area is heated and then cooled, and heated and then cooled, and so on, these stressed areas will suffer thermal fatigue. After tens or hundreds of cycles small thermal fatigue cracks appear at these stressed areas. This is exactly occurring during the grinding process. Each time an area of the journal comes into contact with the grinding wheel that area is heated. During the rest of the rotation the area undergoes cooling. This means that each portion of the journal surface as shows in fig. will be under a thermal gradient, or under a stress gradient, which will be repeated. When the surface warms, compressive thermal stresses occur at that surface (position A in fig.5.3), and when that same surface cools, tension stresses occur at the same surface (position B in fig.5.3). As a consequence, small fatigue cracks, as shown in fig.5.4, will develop at the journal surface.

Fig.5.4 Thermal fatigue cracks aspect.

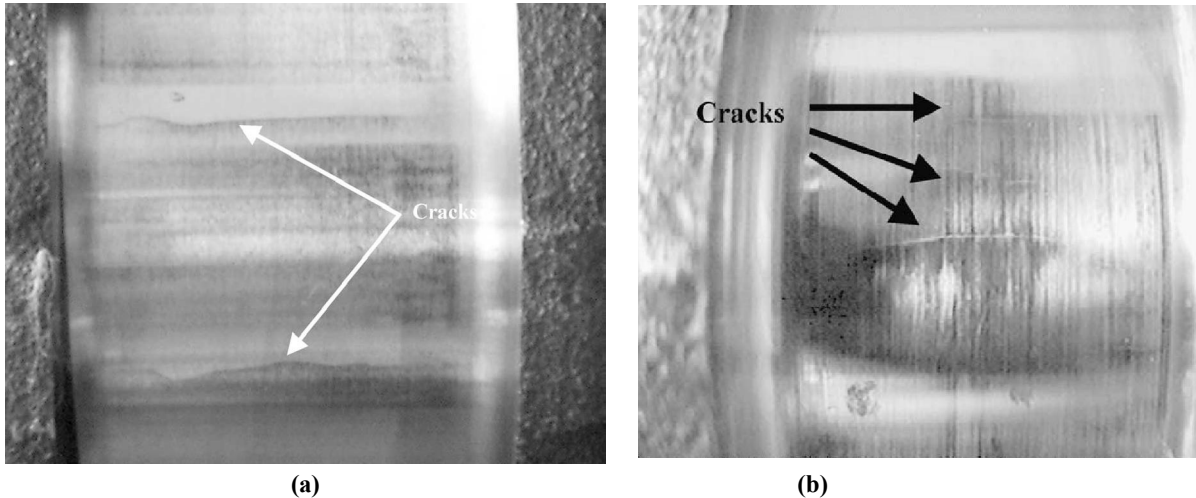
Thermal fatigue cracks develop parallel to the thermal gradient. Also thermal fatigue cracks may be long but with a small depth. These cracks nucleated due to thermal fatigue from the grinding process, and propagated due to heat and stresses as shown in fig.5.5. (a & b). [1]

Fig. 5.5 Cracks parallel to the thermal gradient.

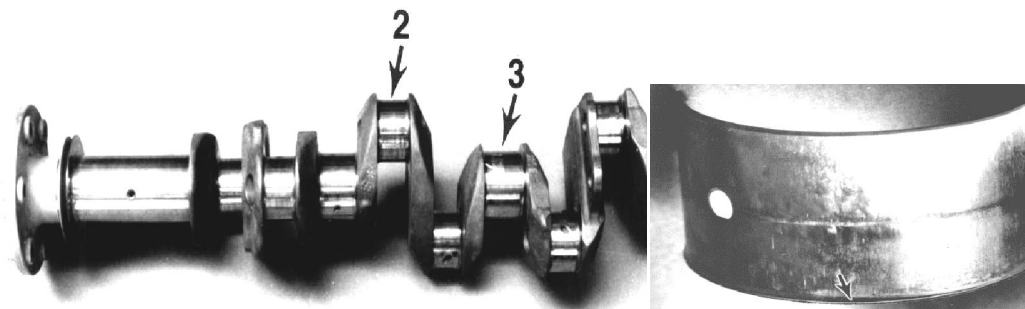
The damaged crank shaft assembly removed from the engine was examined visually. From fig.6.1 the crankshaft was found to have fractured at the No. 2 and No. 3 journals. In both the cases, the fracturing took place along the web radius. Careful examination revealed that the failure had occurred transverse to the axis of the crankshaft, with no evidence of plastic deformation around the fracture zone. The fracture surfaces showed beach marks typical of fatigue failure, and both the fractures were found to have initiated at the web radius region. In journal 3, the fatigue crack had propagated to about 80% of the web section before giving rise to the final, overload fracture. In the case of journal 2, the fatigue crack propagation was about 40% of the web cross section. Also it was seen that the split ring bearing of journal 3 had suffered heavy damage resulting in metal flow and ridging at its edge. This ridging had resulted in the formation of a groove in the softer crankshaft casing made of Al alloy. [4]

Fig. 6.1 Photograph of failed crankshaft and damaged split ring bearing.

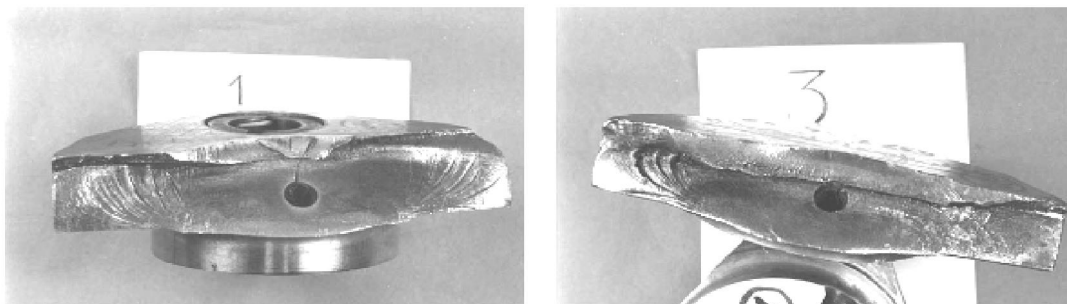
Fig 6.2 shows failed webs of the different crankshafts. The fracture surface presents typical features of fatigue failure. From the orientation of beach marks and other features, the fatigue appears to have initiated from the fillet region interfacing pin and web, and progressed almost over the entire cross section of the web. In some cases multiple origins from the fillet were also noticed. On the other hand, fatigue could also be found to have initiated from the journal side fillet in some other cases and the two fatigue zones culminated near the oil hole resulting in final separation. The overall fatigue surface has about a 45° inclination with respect to the shaft axis.[3]

Fig. 6.2 Photographs of failed webs

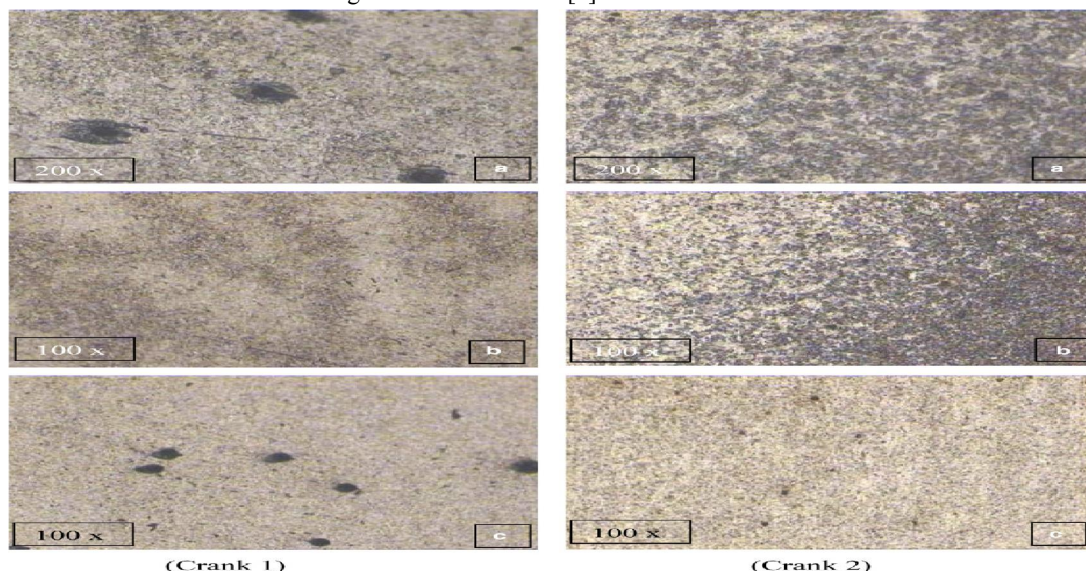
6.4.1 Case 1- The microstructures of the crankshaft materials are given in fig.6.3. The difference between the two microstructures also gives the clue of hardening treatment. From fig. 6.3 (a & b) crank 2 has a hardened surface layer while crank 1 has not. The crank 2 has a tempered martensite structure near the surface regions. The black points observed in the matrix are possibly carbide inclusions grown to very large sizes due to improper production and heat treatment conditions. These inclusions are larger in crank 1 than crank 2 and the difference can be observed in fig.6.3 C. The inclusions in both materials are larger than normal sizes [2].

Fig 6.3 Microstructures of the crankshaft materials

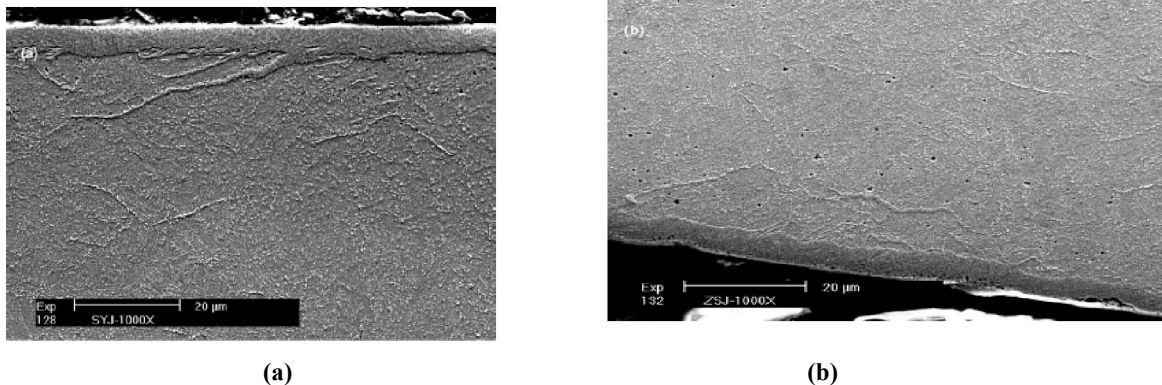
The microhardness profiles from surface to the interior were performed. The results show that a nitrided layer depth of 0.26–0.30 mm can be obtained in general, which is within the range of the technical demand, except for the fillet zone close to the fracture. The microhardness profiles of the two positions in the fillet region of the failed web were measured, one in the fillet zone close to the web or close to the fracture origin region, the other in the fillet zone close to the pin. The measured results are shown in fig. 6.6. It can be seen that there is no hardened layer in the fillet zone close to the fracture origin region, but the depth of the hardened layer in the fillet zone close to the pin is about 0.25 mm.[5].

Fig. 6.4 Microstructure of nitriding layer (a) Journal (b) Crankpin web.

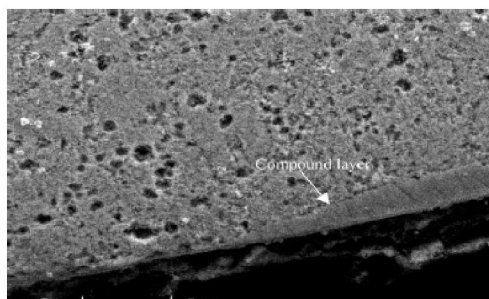
6.4.2 Case 2- Cross sectional specimens of the failed crankpin-web region were prepared to examine microstructure, depth of the nitrided layer, and micro-hardness in order to determine the nitrided layer or the hardened layer. The matrix microstructure of the failed journal and crankpin-web were observed by SEM, and is composed of normal tempered sorbite. By observation of the cross sectional specimens it can be concluded that the crankshaft was nitrided to obtain a compound layer of about 3–6 μm in general as shown in fig 6.4. However, it is found that there is a zone without compound layer in the fillet region on the failed crankpin-web, about 1.6 mm from the fracture origin region as shown in fig. 6.5.

Fig. 6.5 Microstructure of the region close to fracture

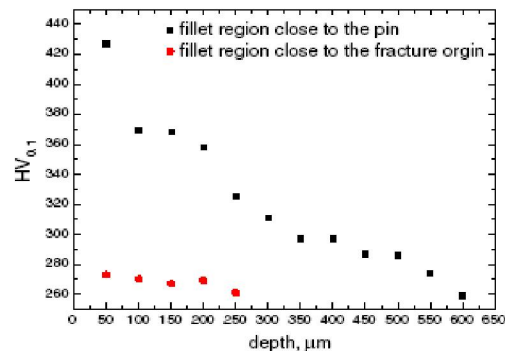
Fig 6.6 Microhardness profile of fillet region of failed crankpin-web.

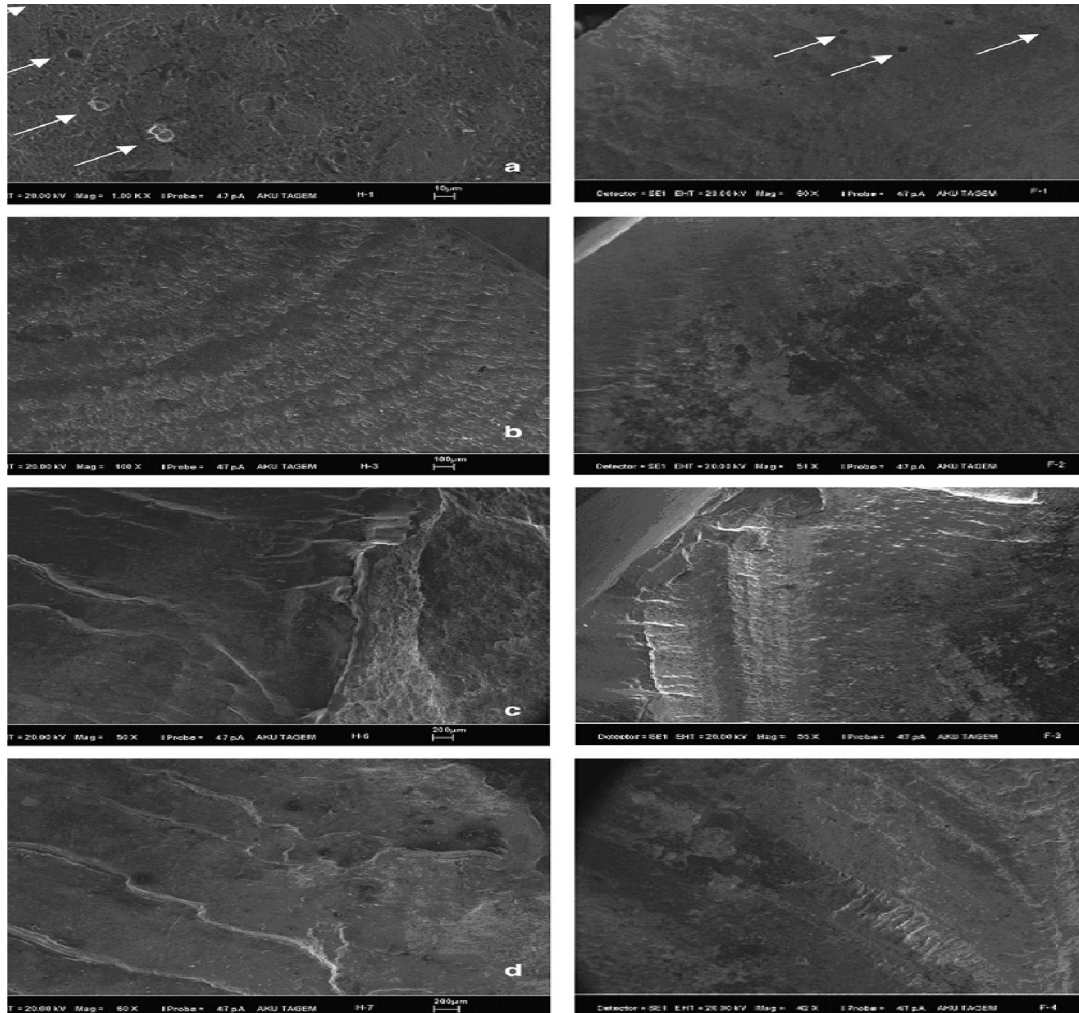
In fig. 6.7 (a) the black regions in fig. 6.3 are visualized as cavities and mounds as indicated by arrows. These locations may lead to initiation of fatigue crack. However smaller carbide inclusions may delay the growth of crack but

inclusions of the present size cause faster failure of the cross sections. The fracture is occurred after a fatigue process as can be concluded from the benchmark striations in the fracture surfaces (fig.6.7 b-d).

Fig.6.7 Scanning electron microscopy (SEM) photographs

The diagonal lubrication holes in the Crank 2 might cause to turn the crack propagation direction and speed up the propagation process. The plastically deformed benchmark lines in fig. 6.7 (c and d) exhibit the unhardened feature of the crank 1. [2]

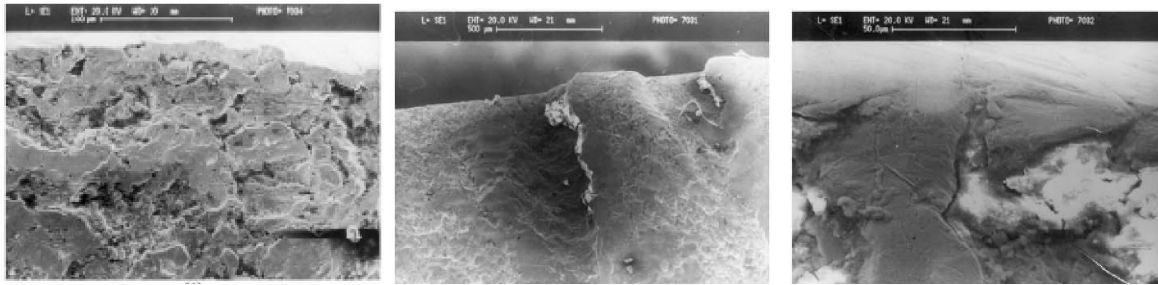
Fig.6.8 SEM photograph

This crankshaft had multiple nucleation of fatigue cracks from the pin-web fillet region. At least two nucleation sites were found to be present. The initiation zone was relatively smooth and did not show unusually long or deep inclusions or cracks. In the fillet region a zone of scattered micro cracks could be seen which appeared to be intergranular in nature as shown in fig.6.8. The fatigue appears to have initiated due to relatively high stress during the fatigue cycle at the initiation stage

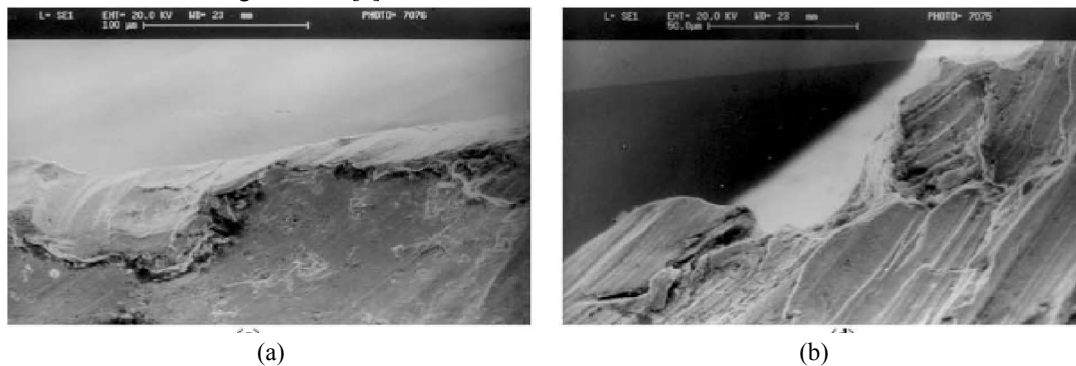
Fig.6.9 SEM photograph

In the pin fillet where fatigue had apparently nucleated, a number of long and deep inclusions of the order of 200–600 mm length and cracks about 100 mm long parallel to the interface as shown in fig.6.8. The inclusions were poorly bonded to the matrix as they had separated at the interface. No intergranular cracks were observed. The fatigue appears to have initiated through the above surface defects which were likely to be the source of fatigue cracking. In the presence of long and deep inclusions and micro cracks, the stress required for fatigue initiation would be reduced.

In this crankshaft, multiple nucleation of fatigue at the pin-web fillet was evident from the nature of beach patterns in the initiation zone. Very close to the surface, long discontinuous cracks (about 400–800 mm length) as shown in fig.6.9 (a). In another location, a surface discontinuity (micro notching, looking like chipping-off of material) was also noticed shown in Fig. 6.9(b) followed fatigue propagation by fine scale cleavage. The presence of such defects is likely to expedite the nucleation of fatigue cracks.[3]

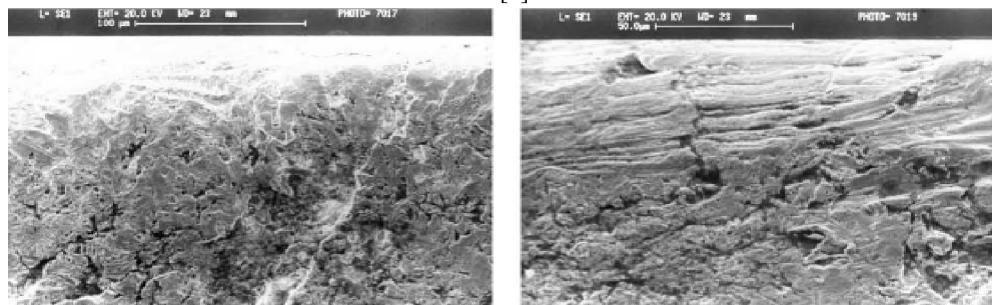
Fig.6.10 SEM photograph

In the fatigue initiation zone of this crankshaft, large scale intergranular cracking and a network of grain boundary cracks were noticed (Fig 6.10). In addition, some cracks were noticed at the surface. The intergranular cracking zone extended over a distance of the order of 600 mm and more. [3]

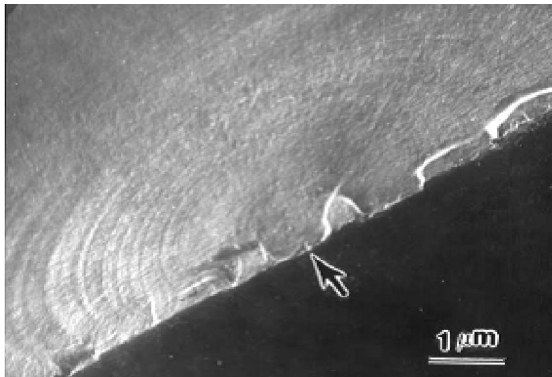
The low magnification fractograph in Fig.6.11 shows the fracture surface at journal. Beach marks, typical of fatigue, are clearly visible. Tracing the beach marks, the fatigue crack origin could be determined and is shown by an arrow in Fig.6.12 The higher magnification view did not show any material defects at the crack origin. However, spalling of the hardened surface layer was observed at several areas (Fig. 6.12). The web radius region at the crack origin is shown in Fig. 6.13. Extensive pitting, spalling and surface cracking can be seen at the crack origin. In addition, scoring marks along the circumference of the web can also be seen. The surface cracks were found to be in a direction perpendicular to that of the scoring marks. [4]

Fig.6.11 SEM of the fractured web at journal showing beach marks and crack origin

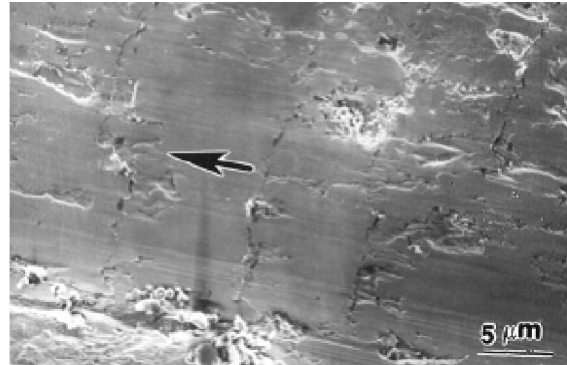
Fig. 6.12 SEM shows pitting, spalling and surface cracking at web radius
