# Structural Audit of Cancer Hospital Building Sawangi (Meghe), Wardha

**Abstract:** Now a Days we are designing RCC framed structure which is heart of building with consideration of factors and various codes which is necessary and using different techniques to assess the old RCC framed Structure. In India, safety of old buildings is one of the major issues. As the strength of old hospital buildings get reduced in due course of time it creates structural defects such as unexpected over loading, material deterioration, physical damages or structural deficiency and if further utilization of such damaged structure is done, it may lead to serious damage of life and property. As Structural Audit of old building is mandatory as per municipal authorities and Government of Maharashtra has made "Structural Audit" of all old building compulsory As Prevention is better than cure, In this present dissertation we adopted Structural Auditing of Cancer hospital building which is situated at sawangi (meghe), Wardha (Maharashtra) is constructed in the year span of 1990-1992 So at the present scenario this building is 32 year Old and required to be checked in all aspect to Assure its safety. with R

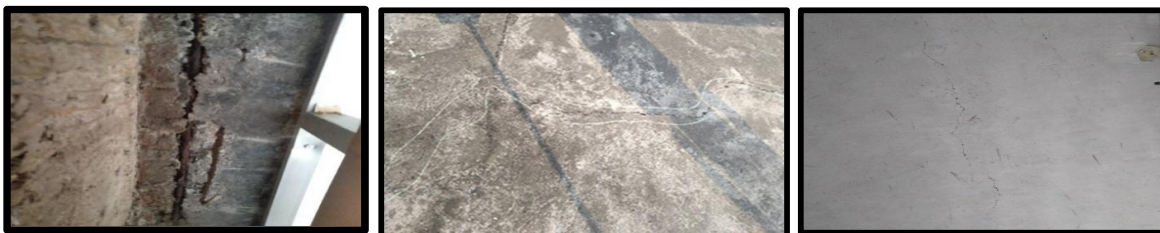
**Figure 2:** Crack Observed

The original grade of concrete was 15 N/mm<sup>2</sup>. Due to carbonation effect and age of concrete strength is reduced. While conducting visual inspection on existing structure we found major cracks in columns, reinforcement exposed on various locations of columns, honeycombing and seepage, deterioration of concrete observed on maximum locations. They are repaired by using epoxy grouting and micro fine cement grouting with epoxy bonding agent, polymer repair and micro concrete.

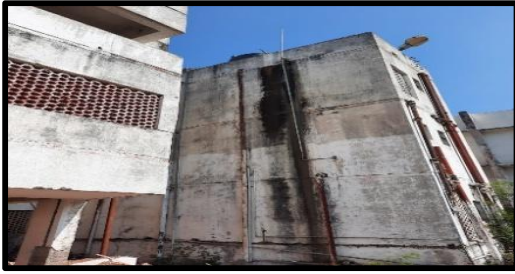
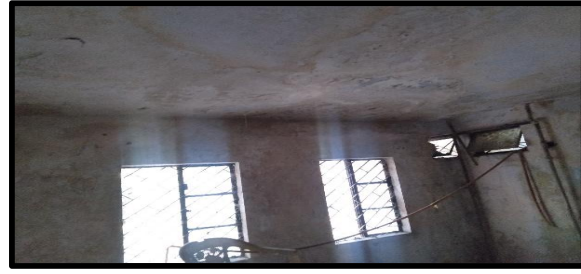
**Figure 3:** Crack and seepage observed.

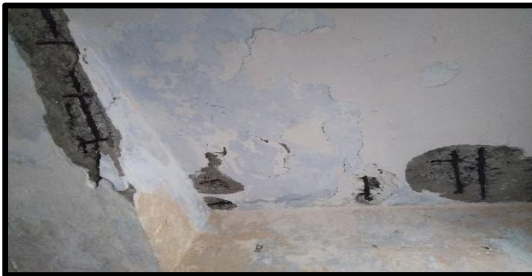
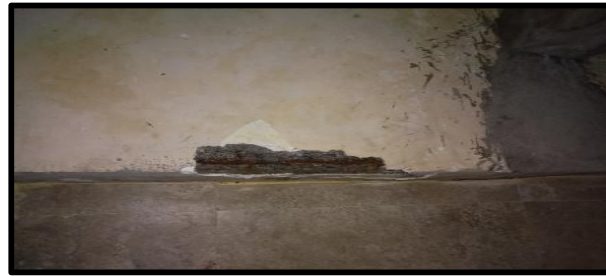
**Figure 4:** Reinforcement Exposed and Concrete Damage

Based on above all Non-Destructive test results it is observed that few locations lintel beam at all floor are damaged and load carrying capacity is reduced. Hence, we had strengthened corresponding weak and damaged beam with Steel beam providing as per methodology and specifications given.

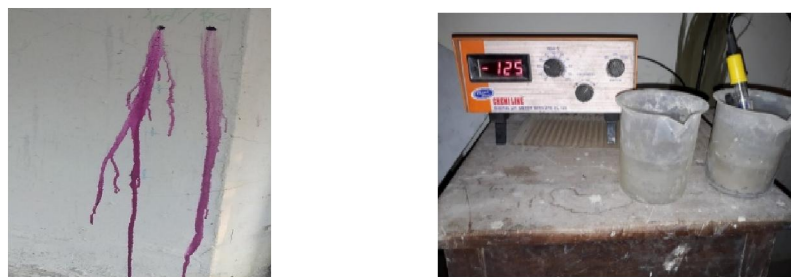
**Figure 7:** pH and Carbonation Test.

When the carbon dioxide in atmosphere in the presence of moisture reacts with hydrated cement, carbonation of concrete occurs. Carbonation process is also called as depassivation. Carbonation of concrete is associated with the corrosion of steel reinforcement and with shrinkage. The method to establish the extent of carbonation in concrete by applying a solution of 15mg Phenolphthalein & 10ml Ethanol diluted in 50ml of distilled water to a fresh fracture surface of concrete. The change of pink color of concrete indicates carbonation free concrete while the uncolored indicated carbonation. The pH of concrete lowers when the carbon dioxide in the air comes in contact with concrete, the process is called carbonation. A standard pH meter is used to measure the pH of concrete.

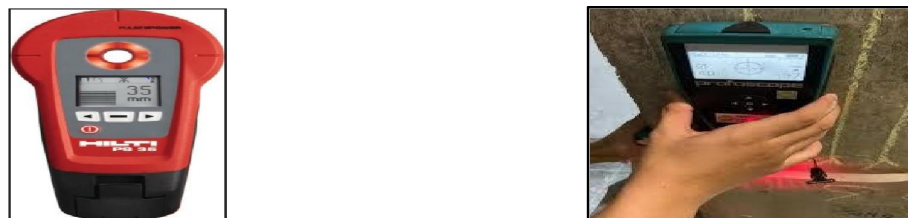
**Figure 8:** Cover Meter Equipment

To prevent corrosion, a sufficient cover thickness is required. A cover thickness survey is helpful in determining current cover thickness in a specific region where damage has been found, as well as elsewhere on the same structure, for comparison. The cover meter is a type of non-destructive test that's also commonly referred to as Cover Meters. The cover Meter is used to locate and measure bar diameters.
